DZ 43301 7/15/2021

# DZ 43301 DODGE RAM TAILGATE ASSIST 1500 2009- 2018 2500/3500 2010 - CURRENT

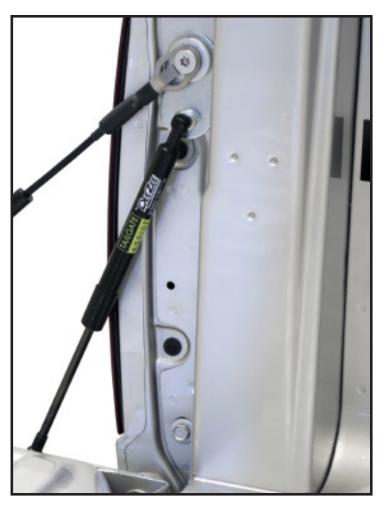
SHOCK	1
BALL MOUNT PLATE	1
NUTSERT TOOL	1
BOTTOM PLATE	1
NUTSERT	1
TORX WRENCH	1
CABLE CLIP	1
MYLAR	1
BOLT	1
T-45 TORX	1
